06 November 2020

55 - 61 MOLESWORTH STREET - NESCS MATTERS

PATTLE DELAMORE PARTNERS LIMITED

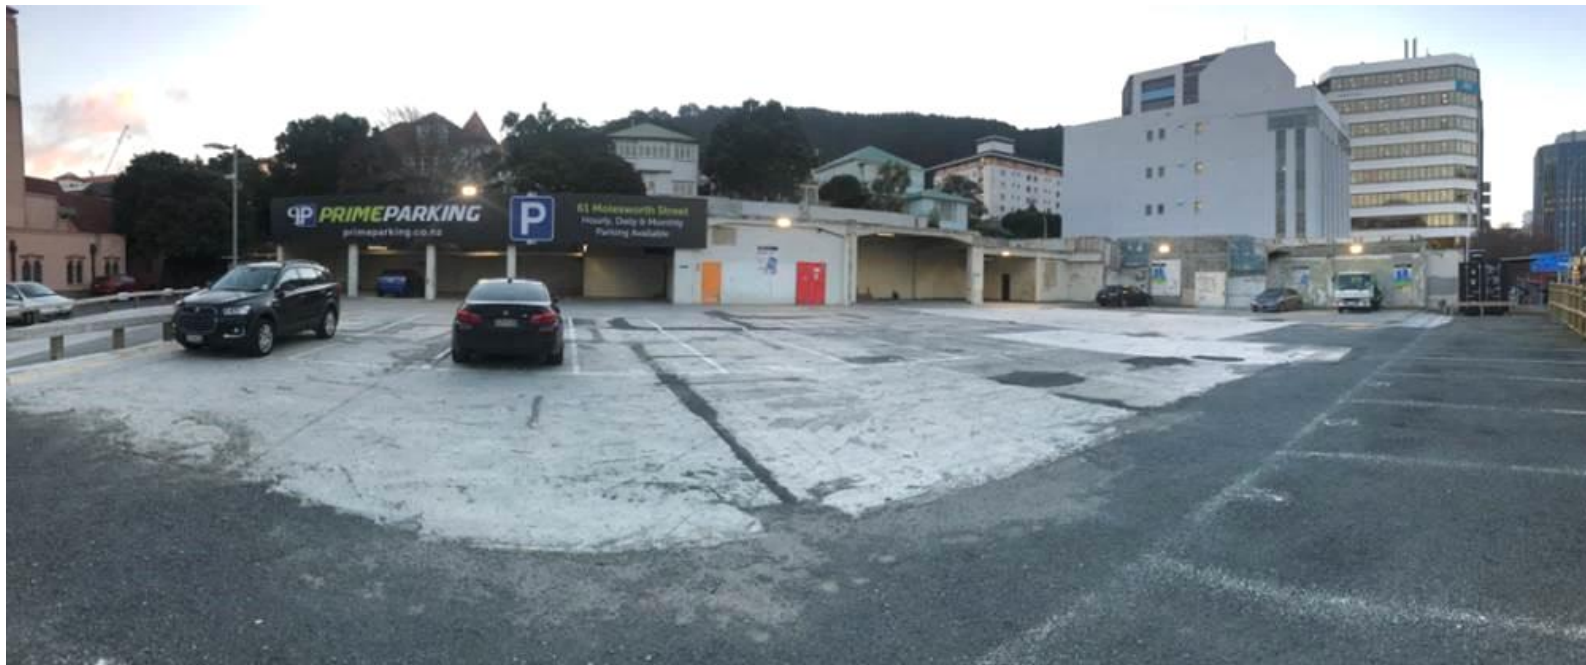
The site is vacant land being operated as a car park. It is covered by a concrete slab which was formerly the basement floor of the building that occupied the site prior to that building being demolished in 2017 following the Kaikoura Earthquake. A panorama of the site taken in 2018 is attached as Photograph 1.

Photograph 1: Panorama of site showing former workshop area (PrimeParking sign above), substation (red door) and plantroom and fuel storage room (black door opening) at the rear of the site, with Molesworth Street visible to the far right. The rear wall and associated workshop and services areas are aligned approximately north-south.

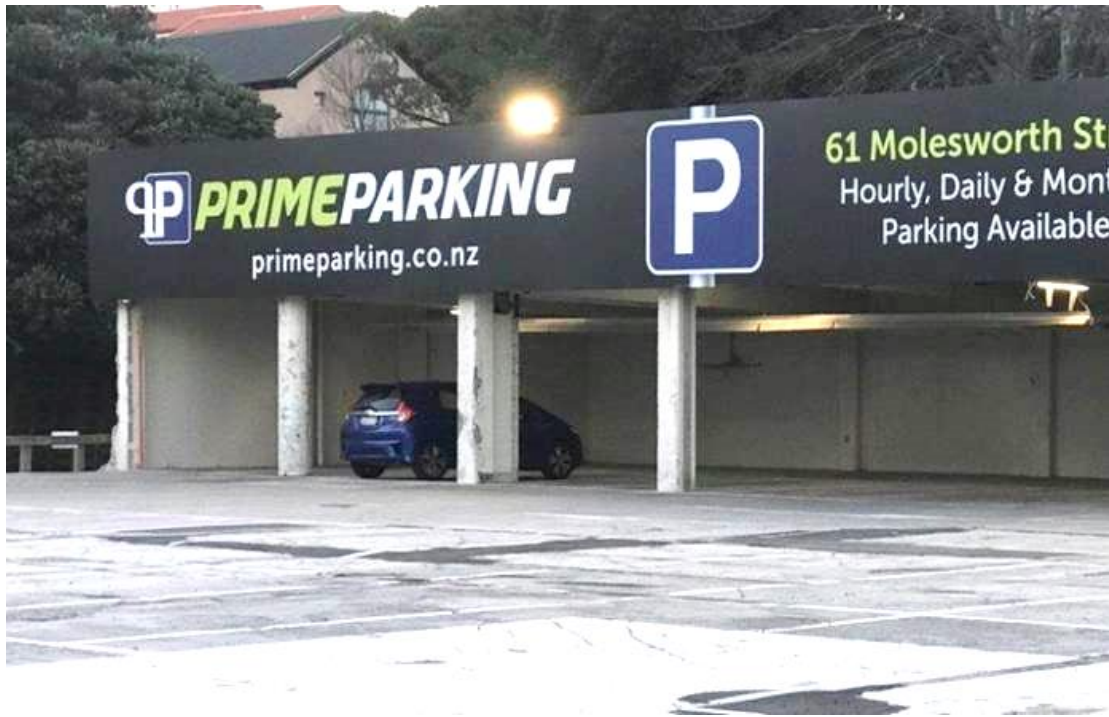
The condition of the rear of the site in 2018 is shown in photographs 2 and 3. Inspection of these areas showed no evidence of underground storage tanks (UST) near the former petrol pumps, and no sign of past workshop use. The former fuel tank room also showed no sign of its former use, with no evidence of staining. The substation was not inspected, being a locked, hazardous area.

Assuming the petrol tanks still exist, it is likely these will be encountered during foundation excavation works. The tanks are likely to extend about 3.5 m below the current ground surface, and therefore any petroleum hydrocarbon residues that may exist around the tanks would be removed along with the material that is excavated for the building foundation. However, if the tank or fuel lines have leaked, residues may extend below the base of the excavation.

The primary risk for petrol residues is generation of vapours that may migrate into building spaces where they may be inhaled over the long term by future occupants, as the complete coverage of the site prevents direct contact with soil. The potential vapour inhalation pathway would only be for the southwestern corner of the building. However, the building design will prevent any such vapour migrating into the office spaces, as the basement creates an air gap which should prevent upward migration of vapours. Consequently, there will be no risk to future occupants from vapours migrating from the presumed tank locations.

Photograph 2: Approximate location of former workshop and petrol tank in southwest corner of site. The petrol pumps were located immediately to the right of the middle column.

If the tanks do still exist, it is a regulatory requirement of the NESCS and the Health and Safety at Work (Hazardous Substances) Regulations 2017 that the tanks and any pipes connected to them are removed, and a soil sampling investigation carried out at the time of the removal by a suitably qualified and experienced practitioner. The WCC must be notified before the tank removal and provided with the soil investigation report after the removal.

If the petrol tanks still exist, these should be removed by a specialist petroleum services company. A soil investigation in compliance with the NESCS regulations should be carried out at the time of the tank removal.

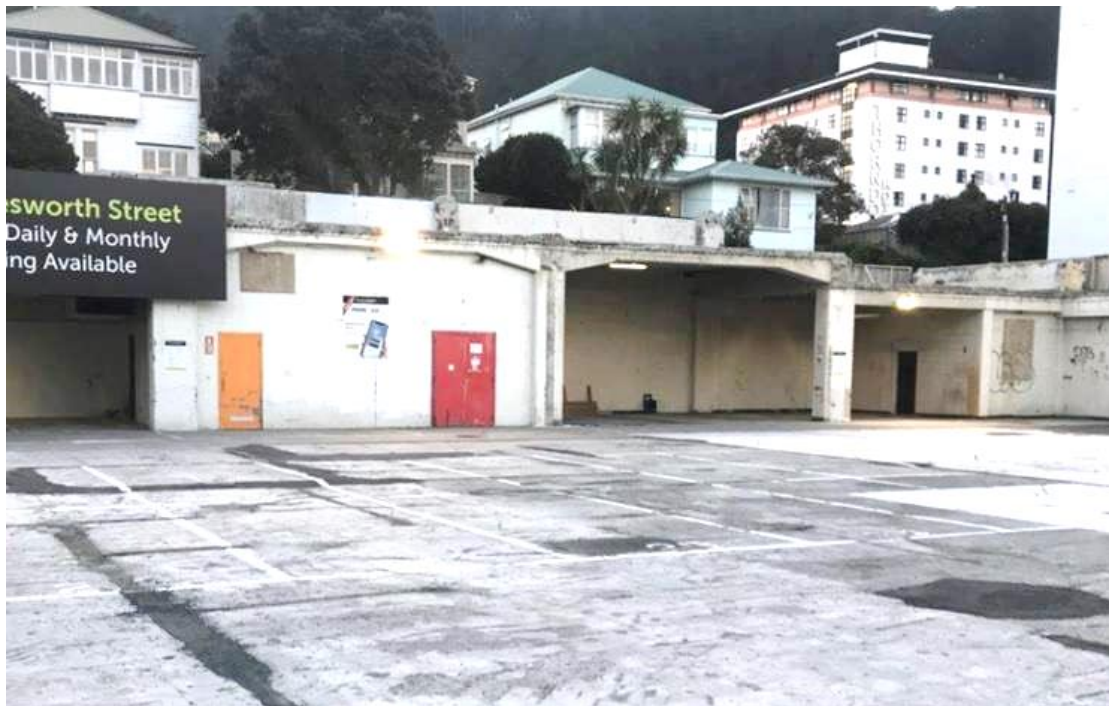
While there is no visual evidence, the above ground tank that contained diesel or similar fuel may have leaked. What appears to be a concrete floor in good condition would most likely have stopped penetration of any leaks or spills into the ground, although this cannot be entirely discounted. While of lower volatility and lower risk than petrol, fuel oil presents similar exposure pathways to petrol.

Photograph 3: View of northwest corner of the site showing, left to right, the enclosed substation, the former plant room which was originally enclosed and, through the door, the fuel oil tank room.

Given the minor risks, there is no need to carry out a ground investigation prior to any development works. It is recommended that, following removal of the existing concrete slab, the ground be inspected at the three locations for signs of contamination, and for the presence of the underground storage tanks (a tank pit should be visible).
